COMBINED FIRE AND HEALTH & SAFETY RISK ASSESSMENT.

Address of premises:	1-7 Sanford Court, Springfield Road, Swindon, SN1 4ER
Responsible Person:	Sanford Court Management Company Limited.
Duty Holder:	Block Management Limited
Assessor:	Rob Cockburn
Report validated by:	John Godfrey, GIFireE.
Date of fire risk assessment:	27 th June 2024
Date of previous fire risk assessment:	N/K
Suggested date for review:	June 2025

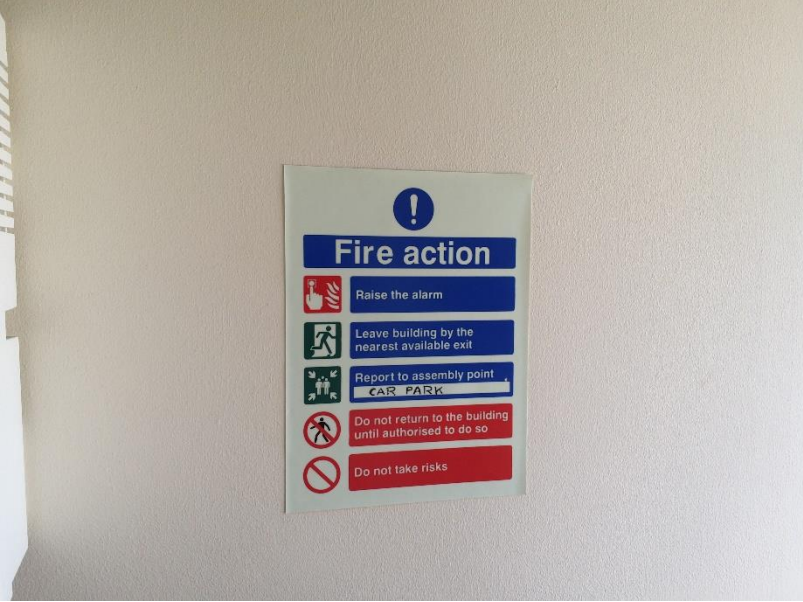
<p>07</p>	<p>A Fire action notice is installed by each exit door however it refers to the incorrect evacuation strategy. It is therefore recommended that a new Fire Action Notice be installed adjacent to each final exit and completed in full. The Fire Action Notice should refer to the correct evacuation strategy for this premises, which is stay put.</p>

<p>3</p>	<p>B</p>	<p>Notice boards to be installed in each communal hallway to improve signage visibility. Stay Put notices to be displayed on these boards August 2024.</p>	
<p>08</p>	<p>It was noted during this fire risk assessment that a fire alarm was installed within the premises. This could be considered as an overprovision for this purpose-built block of flats implementing a stay put evacuation policy. Consideration could be given by the RP as to its removal. This is in line with current fire safety guidance for purpose-built flats.</p>

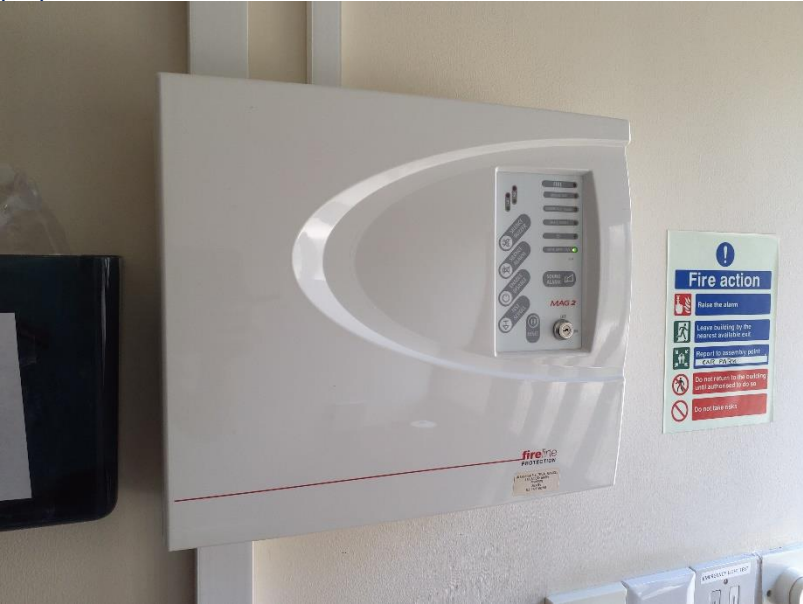
21.4	Where appropriate, are there adequate arrangements for silencing and resetting an alarm condition?	N/A
	Relevant information (including description of arrangements and deficiencies observed):	
	<p>It was noted during this fire risk assessment that a fire alarm was installed within the premises. This could be considered as an overprovision for this purpose-built block of flats implementing a stay put evacuation policy. Consideration could be given by the RP as to its removal. This is in line with current fire safety guidance for purpose-built flats.</p>

<p>3</p>	<p>C</p>		<p>Fire alarm system to be professionally de-commissioned to support Stay Put policy. August 2024</p>
